THERMO-MECHANICAL FATIGUE BEHAVIOR OF  
CROSS-PLY CERAMIC MATRIX COMPOSITE UNDER  
TENSION-TENSION LOADING

THESIS

Dana G. Allen  
Captain, USAF  
AFIT/GAE/ENY/95D-01

DEPARTMENT OF THE AIR FORCE  
AIR UNIVERSITY  
**AIR FORCE INSTITUTE OF TECHNOLOGY**

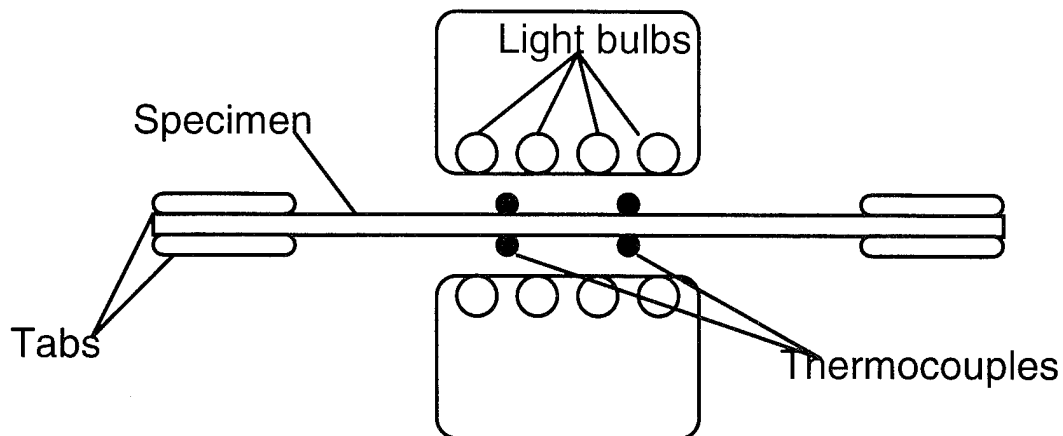
**Figure 4. Specimen Layout**

pair of lights for which they would be providing feedback, as shown in Figure 4. Once they were secure in their proper positions and flat against the specimen, a high temperature alumina oxide (903 Green) adhesive was applied to ensure they would not slip and to cover any exposed thermocouple wire.

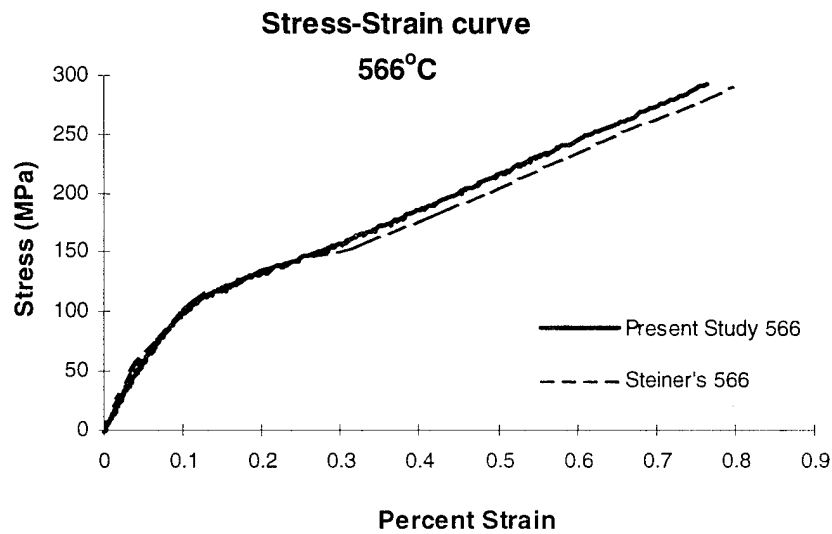
**Figure 6. Monotonic Test: Present Study vs. Steiner's at 566°C**

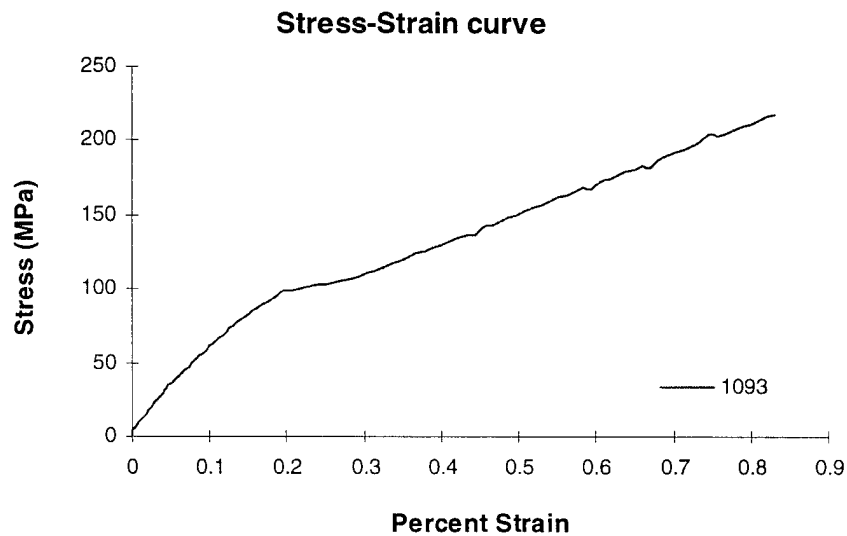
60 MPa, as seen by the knee in the figure. This is the point at which the matrix in the 90 degree plies fail, known as first ply failure. After first ply failure, the material exhibits a linear response up to failure, at 200 MPa for the 1093°C case. The ultimate strain at 1093°C is 0.8 percent. This corresponds well with Steiner's data [15], as shown in Figure 8. Steiner reports an initial modulus of 96.19 GPa, 0.82 percent strain at failure, and ultimate strength of 209.6 MPa.

**Figure 7. Monotonic Test: 1093°C**

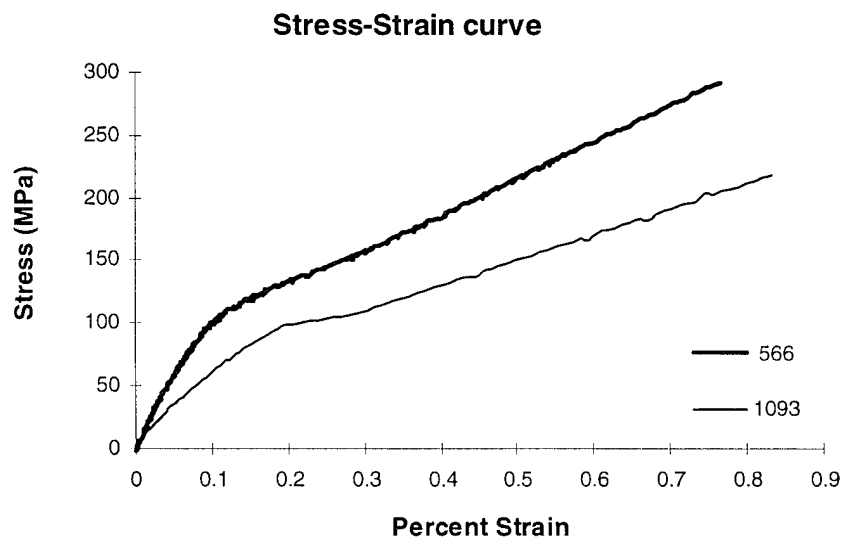
**Figure 9. Monotonic Test: 566°C vs. 1093°C**

Figure 9 shows the stress strain response of the monotonic tensile test at 566°C compared with 1093°C. These curves are of similar shape. At 1093°C, the initial modulus was much lower, and the knee occurred earlier than at 566°C. Ultimate strength occurred at a much lower stress at the higher temperature. Strain at failure was slightly lower at 566°C.

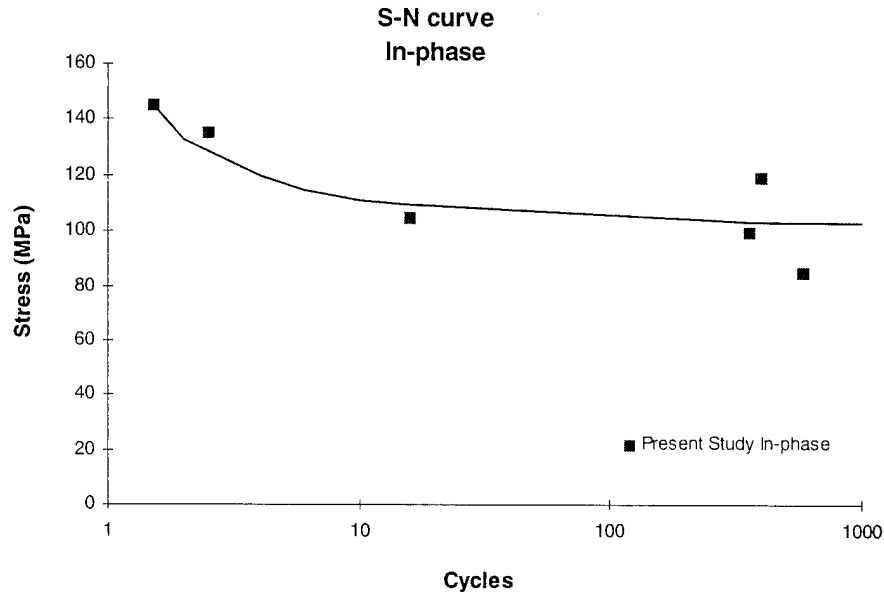
Figure 11 shows the maximum stress to number of cycles to failure (S-N) relationship of the in-phase TMF condition. The data shows a bit of scatter, this is very common in composites, especially in brittle ceramics. The data shows that the fatigue life is inversely proportional to maximum stress. The curve is relatively flat over the entire life and the slope becomes almost horizontal after 10 cycles. The first portion of the curve, prior to 10 cycles, is the region where fiber controlled failure is predominant. Reducing the stress from 145 MPa to 125 MPa will reduce the number of fibers that fail in each cycle, thus it would take slightly longer to fail all of the fibers at 125 MPa than it would at 145 MPa. The second portion (i.e., beyond 10 cycles) is more of a matrix controlled failure. In this region, the fibers do not fail until the fibers become so degraded that they begin to fail or the matrix cracks finally propagate through them.

**Figure 11. In-Phase TMF: S-N Curve**

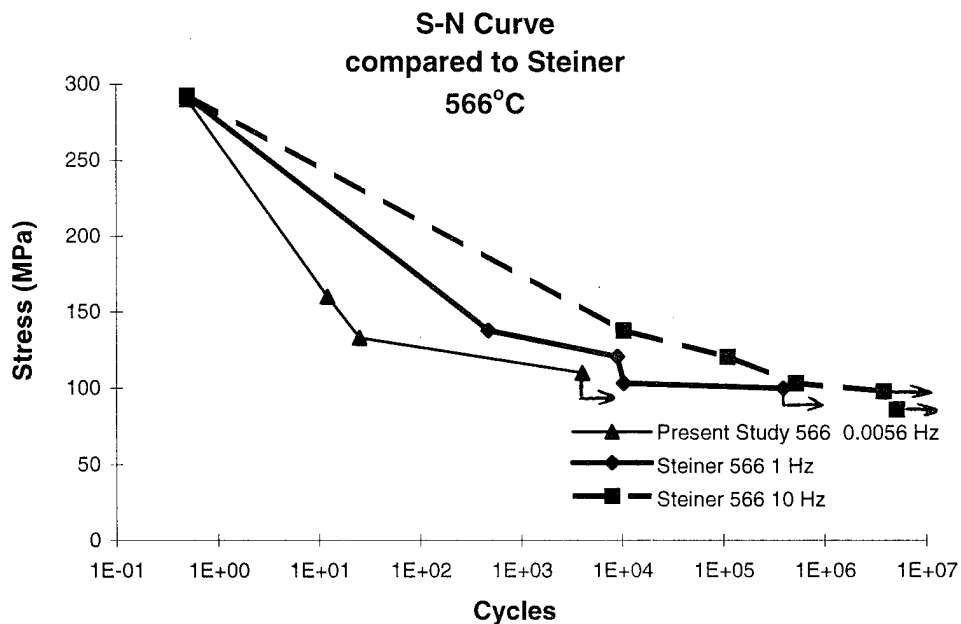
**Figure 26. S-N Curve: Present Study vs. Steiner 566°C [15]**

Figure 26 and Figure 27 show the isothermal fatigue S-N data at 566°C and 1093°C of the present study, respectively, compared to Steiner's [15] data at the same temperature. The low frequency fatigue caused failure in noticeably fewer cycles than the high frequency fatigue. This shows that the material has a greater cyclic fatigue life expectancy at higher frequencies. These curves have the same shape, indicating the transition in the different damage mechanisms is a function of stress, not cycles.

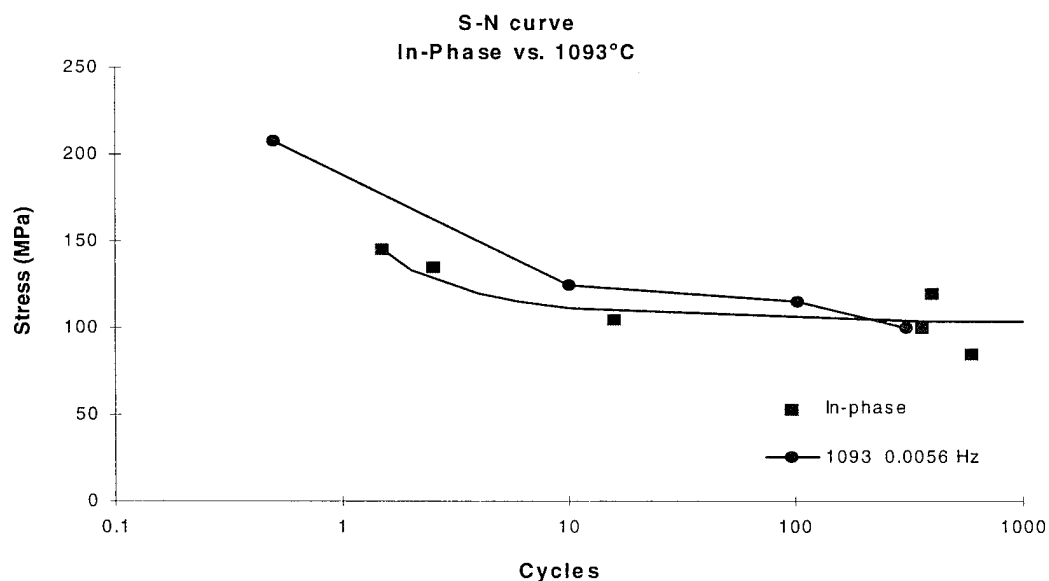
Figure 30 shows the S-N curve for the in-phase TMF tests compared with the isothermal fatigue test run at 1093°C. At stress levels above 120 MPa, both conditions generate fatigue lives within 10 cycles of each other. The TMF was more damaging at these stress levels. At low stress levels, below 120 MPa, the fatigue lives are equivalent.

**Figure 30. In-Phase TMF vs. 1093°C Isothermal**

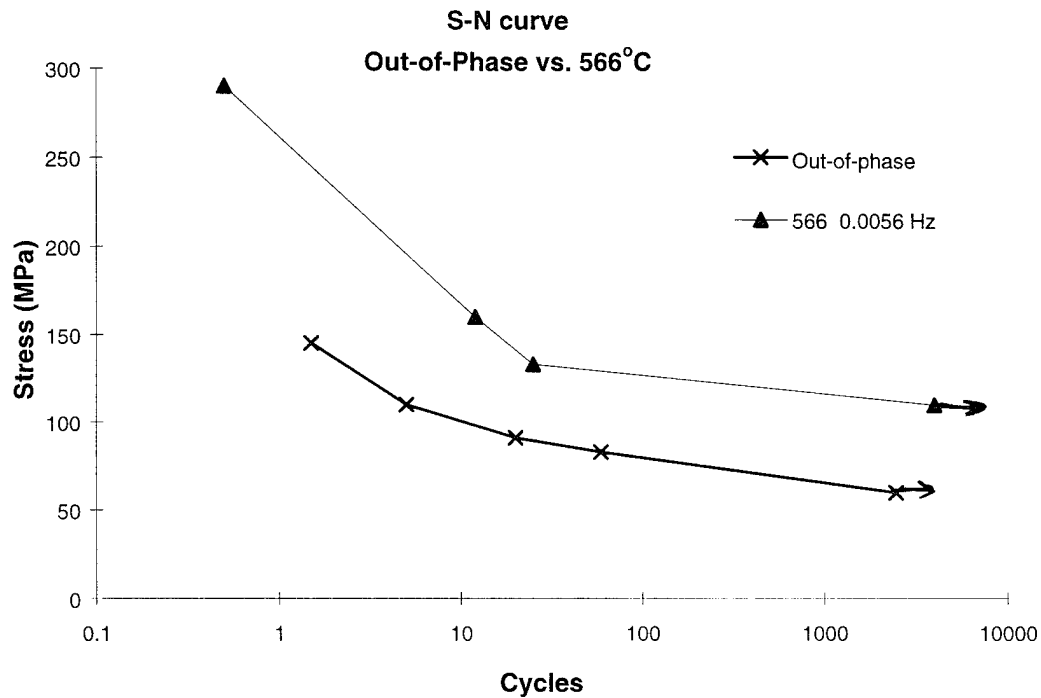
A comparison between the fatigue lives of the out-of-phase TMF with the isothermal fatigue at 566°C is shown in Figure 31. The transition from a combination of fiber and matrix failure to matrix controlled failure occurs at a lower stress for the out-of-phase TMF than it does for the isothermal fatigue. This shows there is an effect of both stress level and loading conditions on the failure mechanisms. At all stress levels the fatigue life of the isothermal fatigue is consistently longer than the fatigue life of the out-of-phase TMF.

**Figure 31. Out-of-Phase TMF vs. 566°C Isothermal**

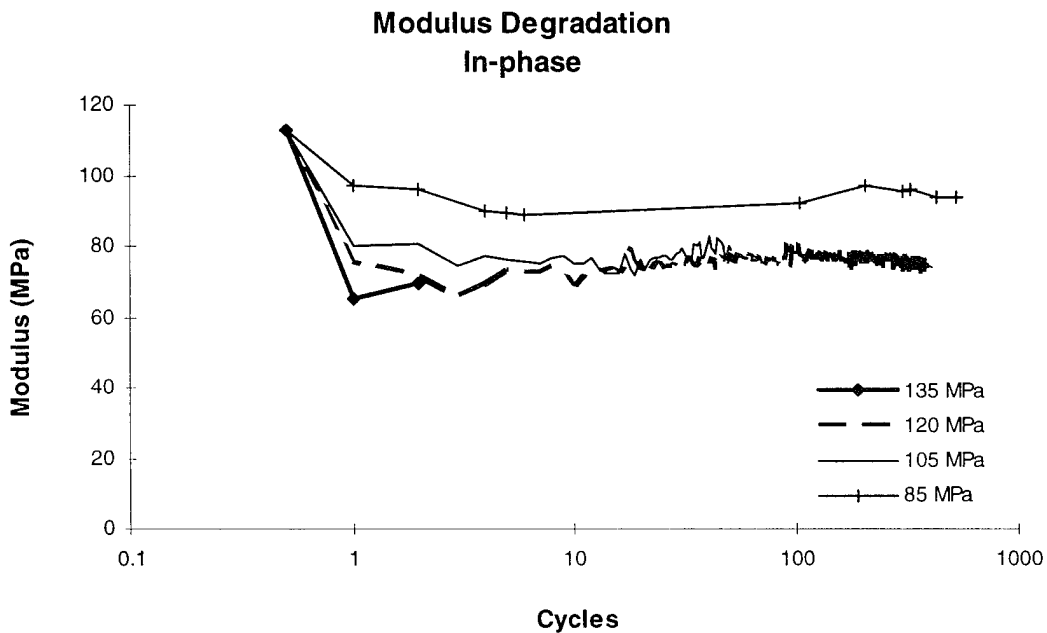
**Figure 58. Modulus Degradation: In-Phase TMF**

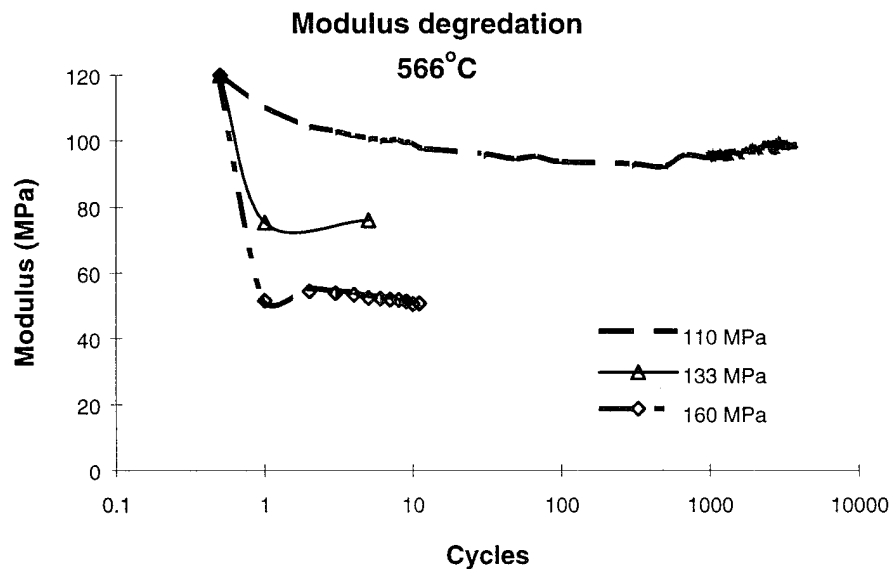
Figure 63 shows how the modulus changed over the fatigue life of the specimens tested under isothermal conditions at 566°C. At high stress levels there was a large reduction in initial modulus in the first cycle, then the modulus tended to remain fairly constant. The fact that the modulus did not decrease indicates that the small strain increase experienced was a creep phenomenon. The initial reduction in modulus indicates that there is a large amount of damage occurring in the first cycle. The modulus of the specimen tested at 110 MPa decreased very slowly. This indicates that there is gradual damage accumulating in the matrix, and strain ratcheting.

**Figure 63. Modulus Degradation: 566°C**

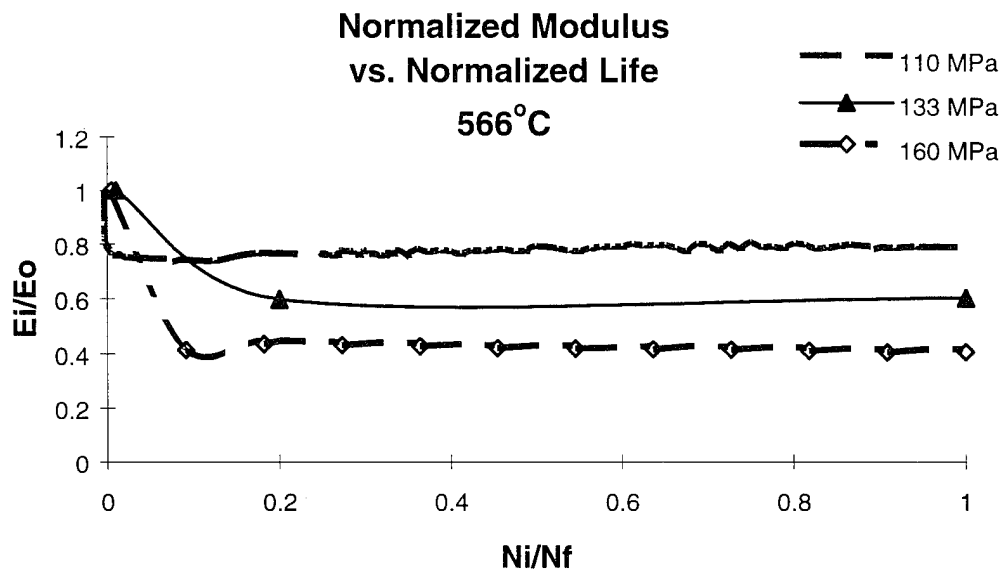
Figure 64 shows the normalized modulus degradation for the specimens tested under isothermal fatigue conditions at 566°C. The stress level of 160 MPa degraded the modulus to about 45%, most of which occurred in the first cycle, indicating that first ply failure occurred in the first cycle. The specimen run at a stress level of 133 MPa degraded the modulus to 58%. Again most of the damage occurred in the first cycle. A stress level of 110 MPa degraded to about 78%. There is no recovery in modulus at this temperature, indicating no increase in shear stress between the fibers and matrix.

**Figure 64. Normalized Modulus Degradation: 566°C**

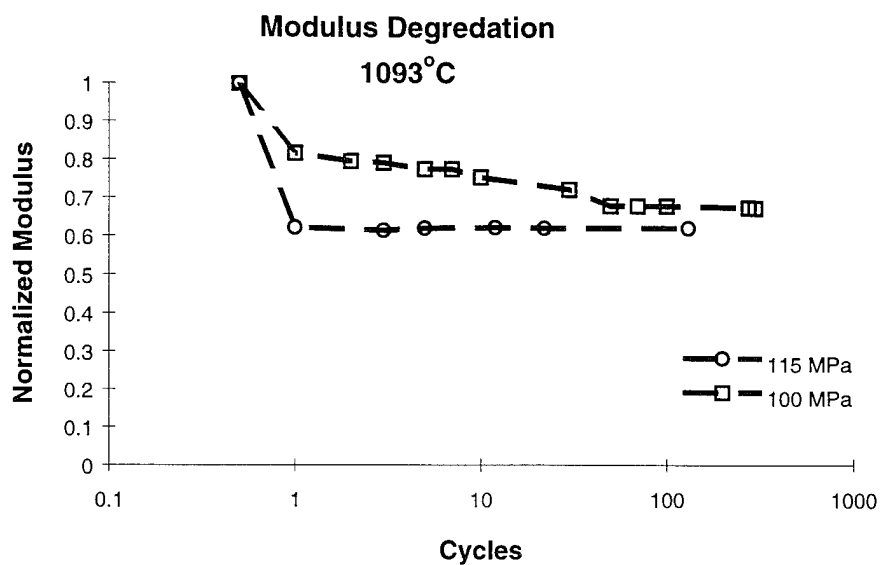
Figure 66 shows the normalized modulus data for the isothermal fatigue specimens tested at 1093°C. The maximum stress level of 115 MPa degraded the modulus to about 60%, most of which occurred in the first cycle, less than 1% of the total life. This indicates that first ply failure occurred in the first cycle. The maximum stress level of 100 MPa degraded the modulus to 80%. Again most of the damage occurred in the first cycle. The modulus then decreased slowly to 65%. This shows that first ply failure did not occur, but matrix cracks did form, and they continued to develop during

**Figure 66. Normalized Modulus Degradation: 1093°C**

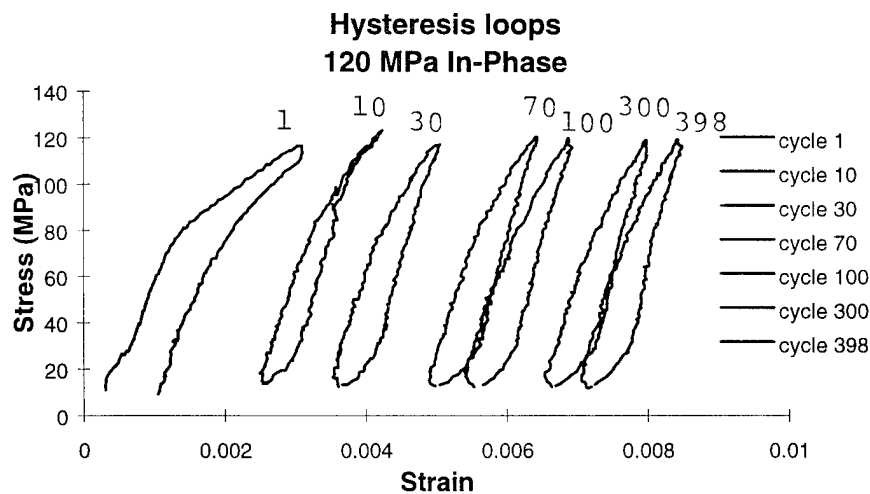
Figure 70 shows the hysteresis loops for in-phase TMF at 120 MPa. The first loop is open, there is a great deal of damage and the material is absorbing a great deal of energy. There is a large lateral shift over the first few cycles, then the shift gets smaller. All the remaining loops have very similar areas and orientations, showing that there is not a large change in modulus of elasticity after the first few cycles. This indicates that there is no fiber breakage occurring. They do tend to migrate with each cycle. This migration is an indicator of strain ratcheting and creep. Notice that the curves are not quite closed, indicating a small amount of plastic like behavior. The area within each curve does not change, indicating no change in frictional shear stress between the fiber and the matrix, which is one of the predominant energy absorbing mechanisms.

**Figure 70. Hysteresis: 120 MPa, In-Phase TMF**

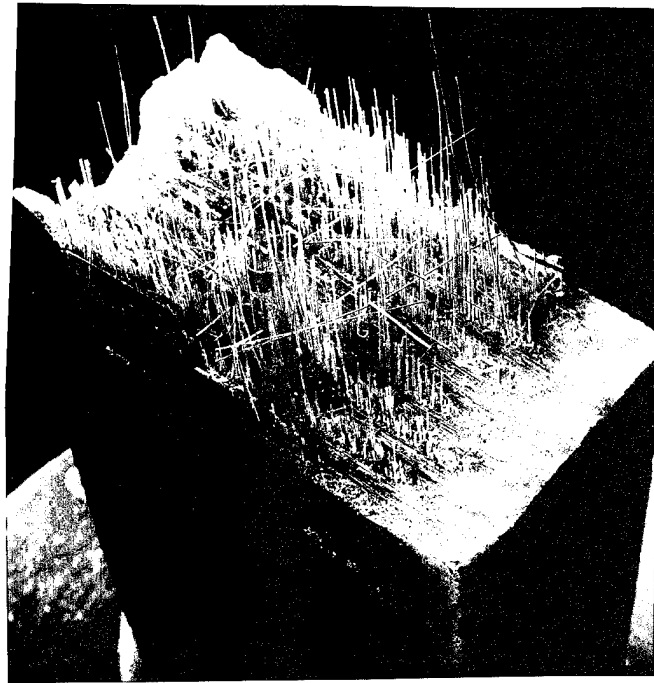
**Figure 81. In-Phase TMF: 145 MPa, Fracture Surface, 12x**

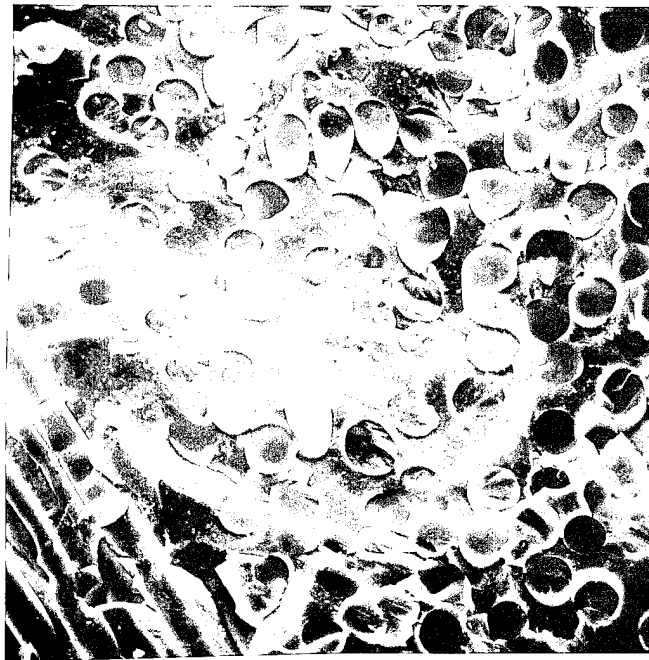
**Figure 87. In-Phase TMF: 100 MPa, Concoidal Fiber Fracture, 600x**

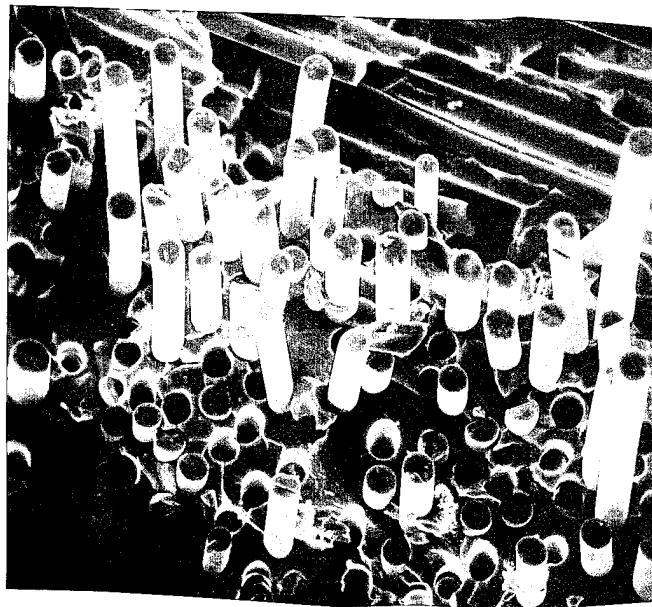
**Figure 96. Isothermal Fatigue 566°C: 133 MPa, Fiber Pull-Out, 550x**
